PNE Public Board Meeting

Community Question - The Sanctuary
Dec. 2, 2021

The PNE Sanctuary

Inspection completed: Nov. 25, 2021

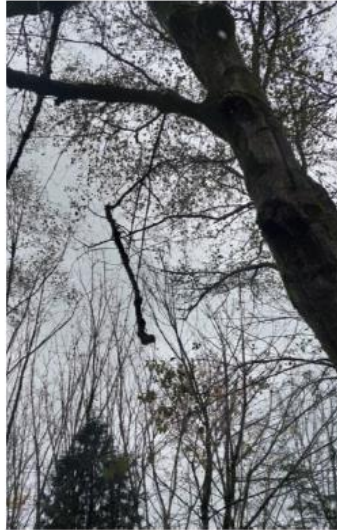
Item # 1	Description: Hanging branches in trees.	
Recommended action: Get ladder and pruning pole to safely remove hanging branches.

Person responsible: Rob Shannon (Gardening Foreperson)		Target date: November 25 th , 2021
Comments: Will be completed today, November 25, 2021.

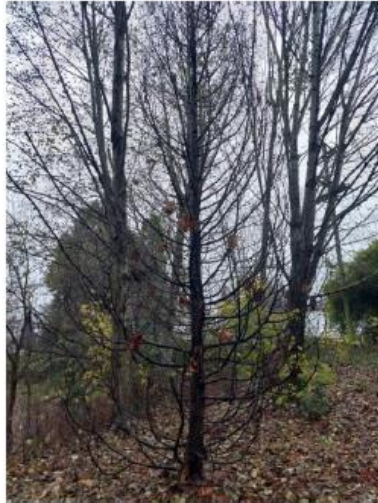
Item # 7	Description: Dead Standing Trees	
Recommended action: To safely fell all dead standing trees in the Sanctuary.

Person responsible: Rob Shannon (Gardening Foreperson)		Target date: Winter and Spring 2022
Comments: Over the past 5 years we have had a rash of Keithia Blight in the sanctuary killing close to 2 dozen cedar trees. Many of them are still standing and could be at risk during high winds and storms.

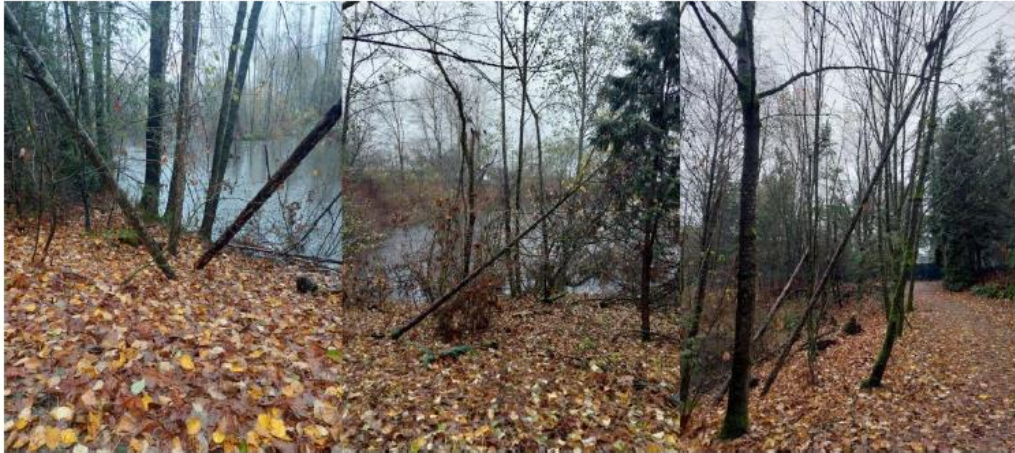
Item # 8	Description: Leaning and Dangerous Trees	
Recommended action: To safely fell all leaning dead standing trees in the Sanctuary.

Person responsible: Rob Shannon (Gardening Foreperson)		Target date: ASAP. Fall/Winter 2021
Comments: Over the past 5 years we have had a rash of Keithia Blight in the sanctuary killing close to 2 dozen cedar trees. Most of them are still dead standing or leaning and could be at risk during high winds and storms. Highest priority for danger to be addressed first.

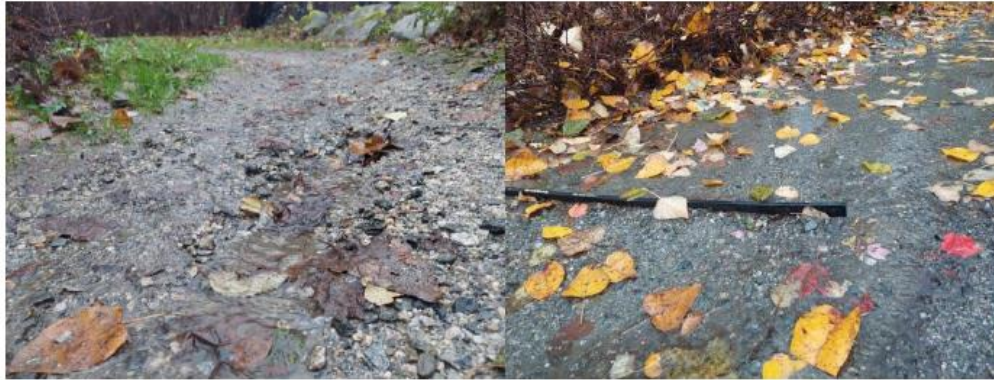
Item
#11

Description: Trip Hazards

Comments: Team needs to remove the built-up gravel on the water side of the black diverters to allow the water to leave the path. Currently the diverters are not functioning.

Recommended action: Rain diverters were installed 4 years ago by the Gardening Crew but require maintenance and repair. This will stop the paths from washing out and creating dangerous erosion by running water.

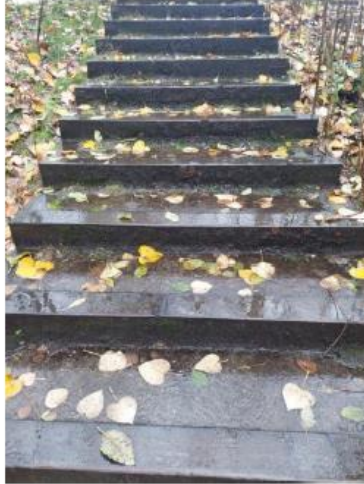
Item #21	Description: Dangerous Steps	
Recommended action: To add expanded metal for grip/railings in areas where the steps have a significant grade and during wet conditions can become very slippery.

Person responsible: Rob Crema/David Law		Target date: Winter 2022
Comments: PNE Machine Shop/ Carpenters will be engaged to complete this work

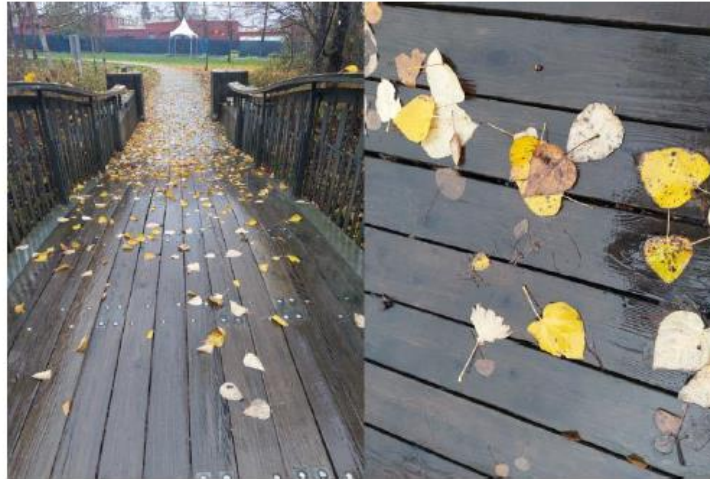
Item
#25

Description: Slippery Bridge deck

Recommended action: To add expanded metal for grip on the "hump" bridge in the north end. This will allow for pedestrians to gain grip and traction while crossing this "humped" bridge.

Comments: PNE Machine Shop/ Carpenters will be engaged to complete this work

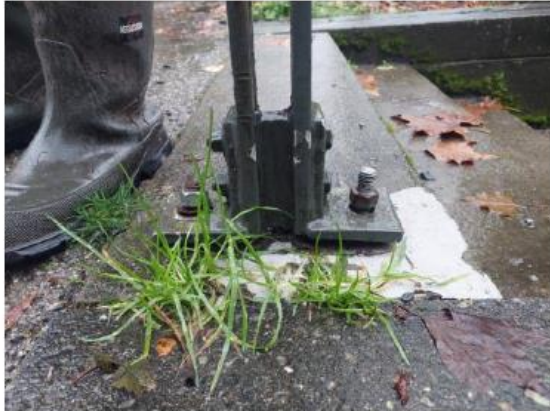
Item #26	Description: Loose hand railings	
Recommended action: Tighten down hand railing. It was temporarily removed for operational requirements this spring and needs to be tightened

Person responsible: Rob Crema/David Law		Target date: Winter 2022
Comments: Recommend an assessment of rail integrity to see if any additional repairs are required. PNE Machine Shop/ Carpenters will be engaged to complete this work

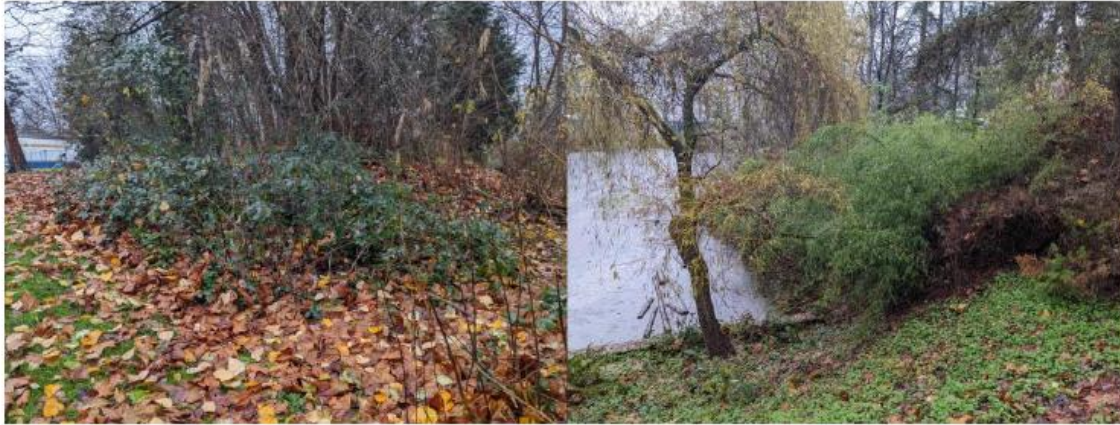
Item
#31

Description: Invasive Species

Comments: This will be quite a significant project as reduced resources during COVID have meant little work has been done on invasive species in the past 18 months

Recommended action: To restart our invasive species removal in the Sanctuary. The Blackberry, Bamboo and Potato Vine have become very overgrown over the COVID period.
